Re: New Canaan Teen Center – Structural Survey
77 Main Street
New Canaan, CT 06840
TDEG Project No. 16153.00

Structural Engineering Survey
New Canaan Teen Center
77 Main Street
New Canaan, CT

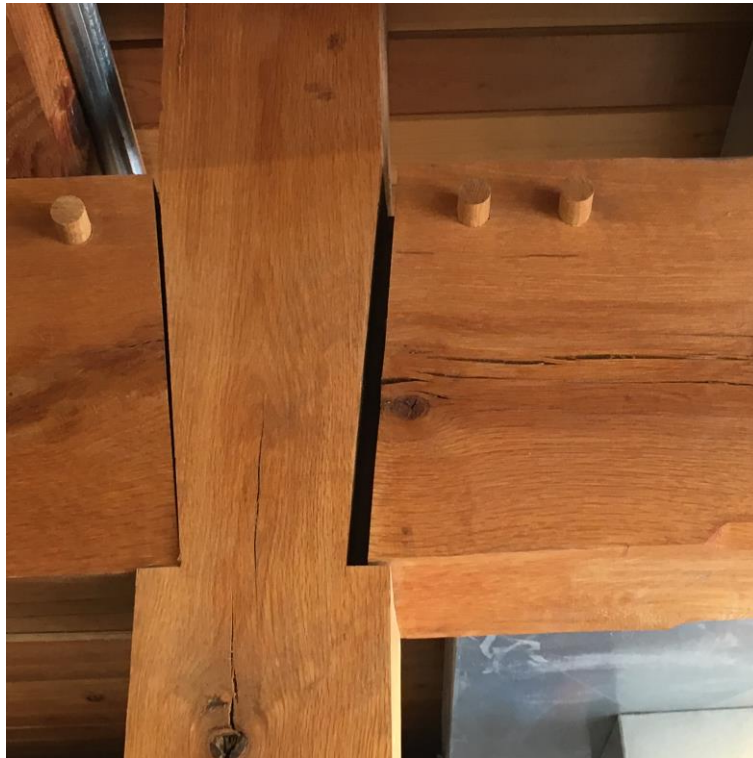
No. 3

- a. Gaps between end of beams and posts of up to $\frac{1}{2}$ " are prevalent, leaving a beam that originally had 1" of bearing now has $\frac{1}{2}$ " of bearing, **see Photo No. 3**. Gaps of this amount are greater than can be attributed to seasoning alone and suggest some amount of external tension is separating the beams from the posts. The tension connection between post and beam appears to be separate block of wood, acting as a tenon, that is mortised into the top of the beam and through the post. The block of wood then appears to have been pegged/ doweled to the post and beam. The separation suggests that the dowel has pulled through the tenon. **See Photo No. 4**.

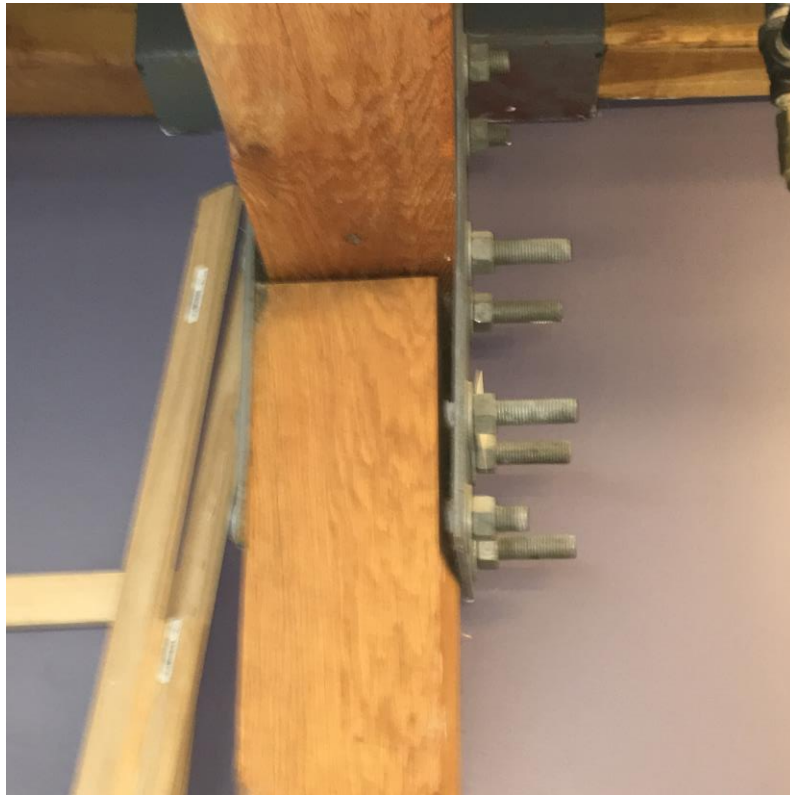
No. 5

- b. Steel plates have been bolted to both sides of the girder/ post connection at several locations under the main level along the east side (facing Town Hall). The steel plates have been distorted by tightening of the bolts bending the plates over uneven surfaces. Nuts were loose in a few instances. **See Photo No. 5**

- c. Beams have twisted or warped at their ends causing uneven bearing and offset bearing on supporting surfaces. **See Photo Nos. 5 & 6**
 - d. At the northernmost roof truss, the top connection at the exterior wall has been thru- bolted unlike the other 4 trusses. The purpose of these bolts was not determined. **See Photo No. 7**

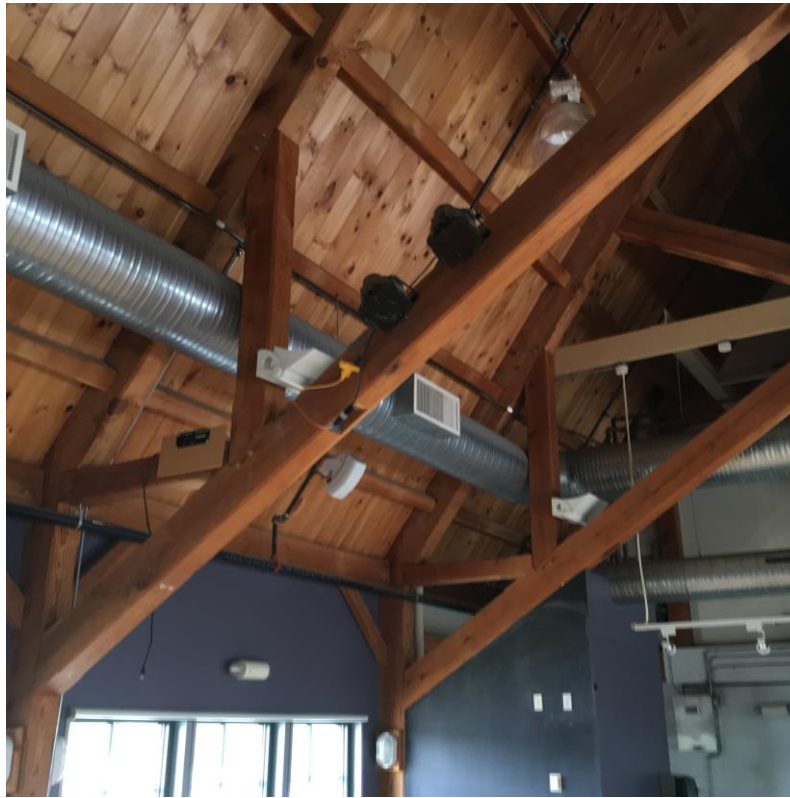
No. 7

8. Overall framing plan has little lateral bracing in the east-west direction other than the stthat rigidify the connection, **see Photo No. 9**, and the connection of both top and bottom chords of the scissors truss to the exterior post, **See Photo No. 7**.

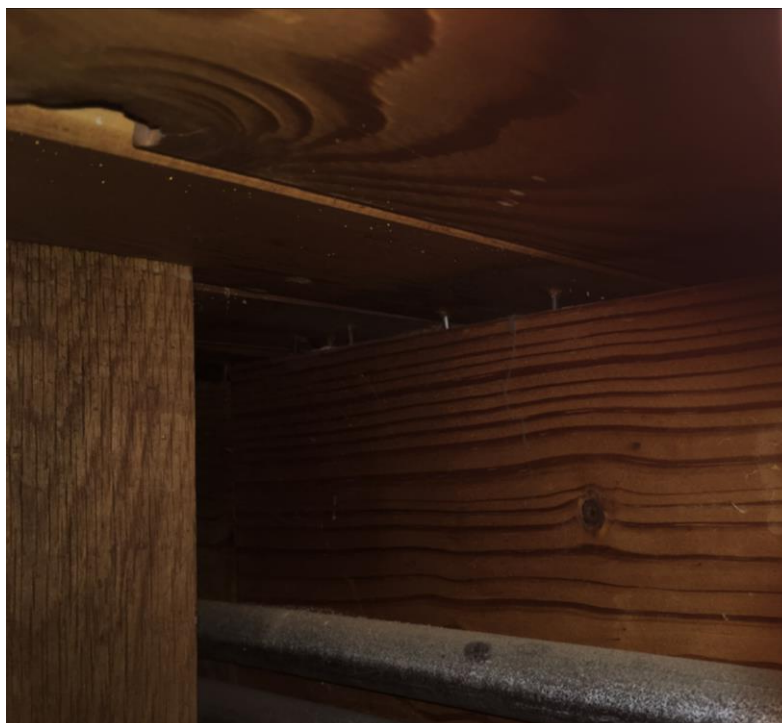
No. 8

6. The nailing for the flooring/ decking has pulled out of the joists at locations. No readily apparent reason. **See Photo No. 8**
 7. Foundation wall on west side retains approximately 4 feet of fill above the floor slab. If not installed as a cantilever retaining wall having a reinforced wall and footing, and the footing wider than is normally used there may be some lateral soil pressure exerted on the framed structure

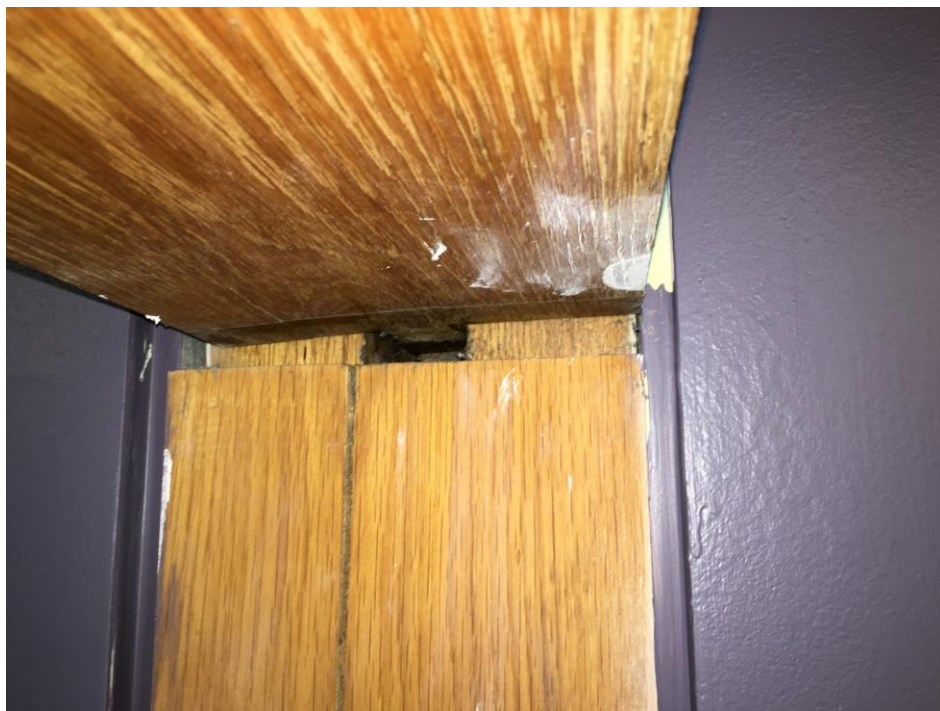
No. 10

9. Beams are lifted off their post bearing seats, the opposite effect would normally be expected, due to gravity forces, the beam would seat itself. **See Photo No. 10**
